Original Paper

The anti – Temperature-vibration properties of viscoelastic anticorrosive tape

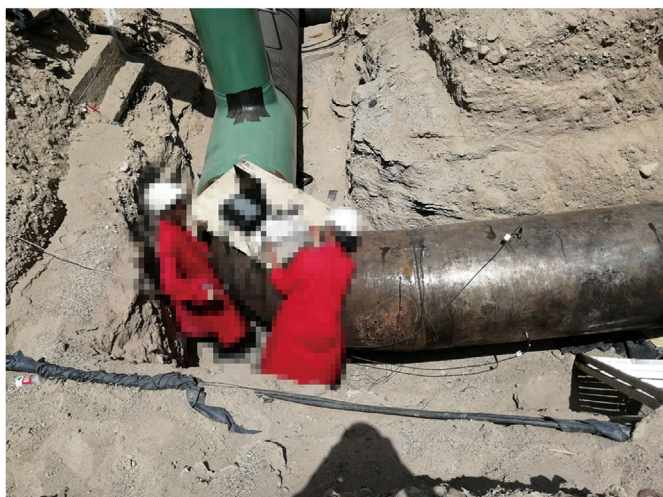
To simulate the vibration characteristics of the coating failure section of a pipeline, a vibration spectrum test was conducted in Kongquehe compressor station. The test pipeline section is shown in Fig. 2. The original anticorrosive layer of the test pipe was a fusion-bonded epoxy powder coating (FBE), and excavation detection was used to determine that a large area of local anticorrosive layer was detached from the pipe, leading to serious corrosion of the pipe wall. The pipeline operator intended to repair the damaged pipeline anticorrosion coating using a viscoelastic body. The purpose of this paper was to verify the bearing capacity of the viscoelastic anticorrosion coating with regard to the temperature and vibration conditions of the compressor outlet pipeline. The pipeline vibration spectra were thus measured during compressor commissioning.

Fig. 2. Field condition of tested pipe section.

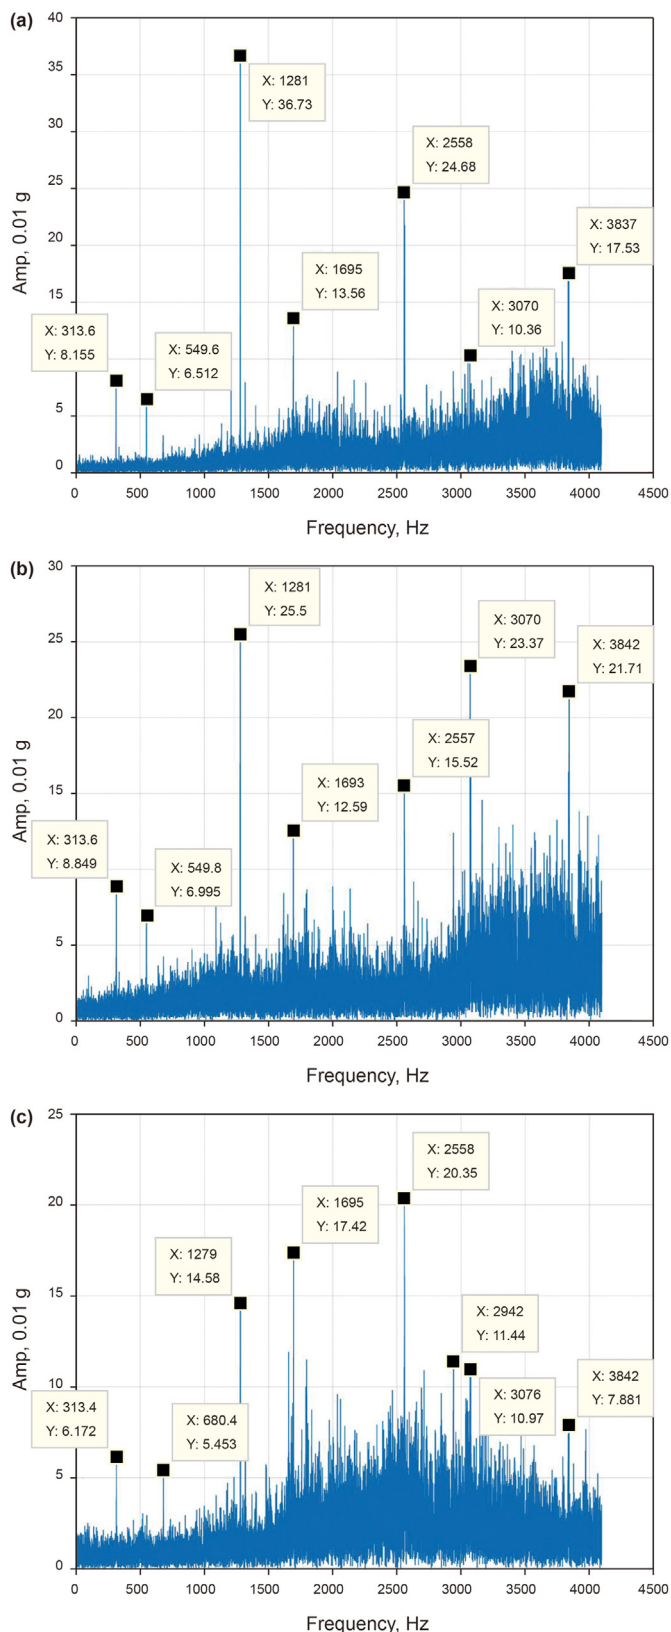
The pipeline vibration spectrum test results for the three measurement points are shown in Fig. 4. The main frequency components in all three directions were 313.6 Hz, 1281 Hz, 1695 Hz, 2558 Hz, 3070 Hz, and 3842 Hz. Thus, it was preliminarily concluded that the main vibration frequency of the output pipeline during this trial operation included these frequency components. Among these frequency components, 1281 Hz, 2558 Hz, and 3842 Hz exhibited an obvious frequency doubling relationship. It was therefore inferred that these three frequency components were the vibrations caused by excitation of the compressor frequency. As shown in Fig. 4, the acceleration at the point with the highest amplitude was about 0.37 g and the frequency at this point was 1281 Hz. A greater frequency and amplitude mean greater structural vibration damage. Therefore, 1281 Hz and 0.37 g were selected as the rate and amplitude for the laboratory simulation test.

Fig. 4. Vibration measurement results during compressor commissioning: (a) measurement point 1, (b) measurement point 2, (c) measurement point 3.

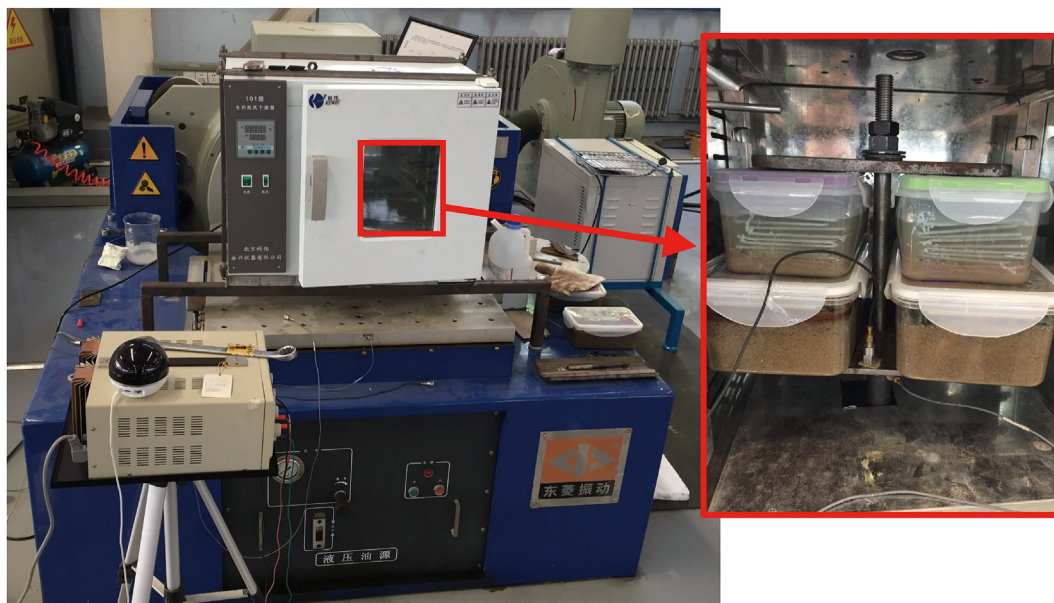
In this experiment, the vibration parameters were the main frequency (1218 Hz) and acceleration (0.37 g) obtained from the field tests, and the maximum temperature of the compressor outlet pipe was 70 °C (according to the compressor outlet pipeline temperature monitoring data of pipeline operators). To ensure consistency between the indoor simulation experiments and the field environment, the researchers extracted approximately 5 kg of soil from the Kongquehe compressor station to use in the indoor simulation experiments. The specimens were buried in a sealed container containing the soil and water from the site. The buried specimens were then treated with the coupled high temperature and vibration conditions for 30 days, as shown in Fig. 5.

Fig. 5. Coupled temperature and vibration loading experiment process.

temperature and vibration at a compressor outlet by experimental means (Nie et al., 2021). We obtained relatively reliable research results from this study. Thus, this work adopted the same method to test the viscoelastic antiadhesive tape. In order to ensure that the anticorrosion coating specimens bore the specified vibration load at a constant test temperature, an accelerated temperature and vibration coupling test was conducted to simulate the operational condition of the anticorrosion layer at the compressor outlet in the Kongquehe compressor station. The temperature and vibration platform was independently developed by the project team, and this platform met the requirements of a 24-h uninterrupted coupled loading of temperature and vibration. The maximum heating temperature of this platform was 200 °C, and the vibration frequency range was 5–2700 Hz. A camera was used for real-time
